Contract #: 04-0120F4Cty: SF/ALA Rte: 80 PM: 13.2/13.9File #: 69.28**WELDING INSPECTION REPORT****Resident Engineer:**Pursell, Gary**Address:** 333 Burma Road**City:** Oakland, CA 94607**Report No:** WIR-014923**Date Inspected:** 18-Jun-2010**Project Name:** SAS Superstructure**OSM Arrival Time:** 1900**Prime Contractor:** American Bridge/Fluor Enterprises, a JV**OSM Departure Time:** 700**Contractor:** Zhenhua Port Machinery Company, Ltd (ZPMC), Changxing Island **Location:** Shanghai, China**CWI Name:** See Below**CWI Present:** Yes No**Inspected CWI report:** Yes No N/A**Rod Oven in Use:** Yes No N/A**Electrode to specification:** Yes No N/A**Weld Procedures Followed:** Yes No N/A**Qualified Welders:** Yes No N/A**Verified Joint Fit-up:** Yes No N/A**Approved Drawings:** Yes No N/A**Approved WPS:** Yes No N/A**Delayed / Cancelled:** Yes No N/A**Bridge No:** 34-0006**Component:** OBG**Summary of Items Observed:**

OBG Segment Trial Assembly

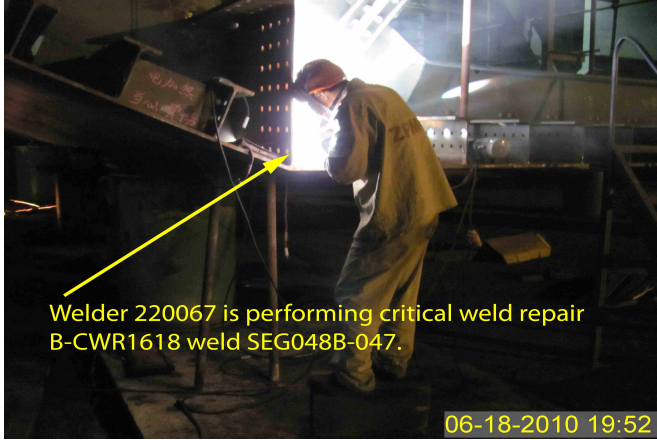
This QA Inspector observed ZPMC welder Mr. Chen Zheng Hua, stencil 220067 is using shielded metal arc welding procedure WPS-345-SMAW-2G(2F)-FCM-Repair-1 to make 2G (horizontal) position shielded metal arc repair weld SEG48B-047 as authorized on critical weld repair document B-CWR1618. This weld had been ultrasonically rejected and is located at OBG segment 8CE in the trial assembly area. This QA Inspector observed Mr. Chen Zheng Hua has a portable light that he is using to illuminate this weld repair area. This QA Inspector measured a welding current of approximately 160 amps and Mr. Chen Zheng Hua appears to be certified to make this weld. This QA Inspector observed the welding electrodes are being stored in a heated portable electrode storage oven. This QA Inspector observed that the weld and adjacent base material had been being preheated with an electric heating element that is located on the exterior side of this weld. Items observed on this date appeared to generally comply with applicable contract documents. See the photograph below for additional information.
